When Disaster Strikes: A Guide to Manage, Recover & Prepare

FIRE!!!

**Lessons Learned
At
USC Upstate**

USC Upstate Sports Turf Facility

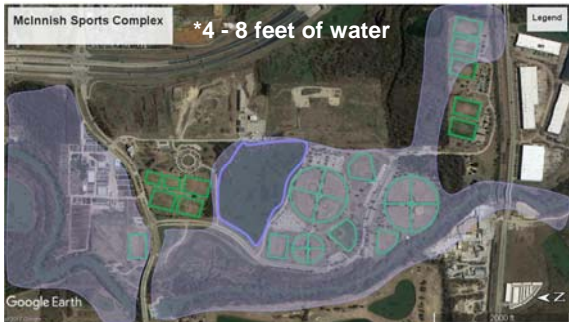
McInnish Sports Complex

*4 -8 feet of water

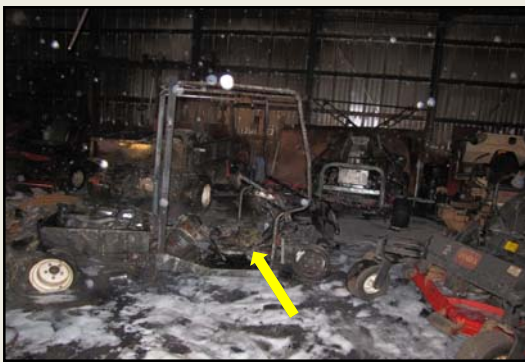
Suspected Origin

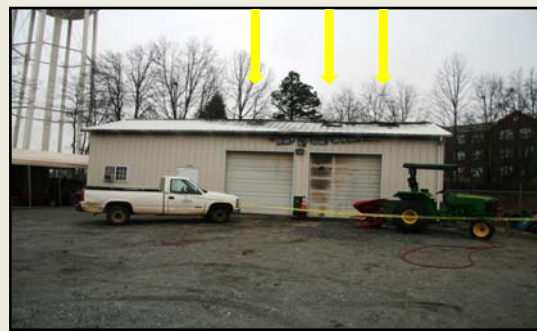
Skylights Provided Ventilation

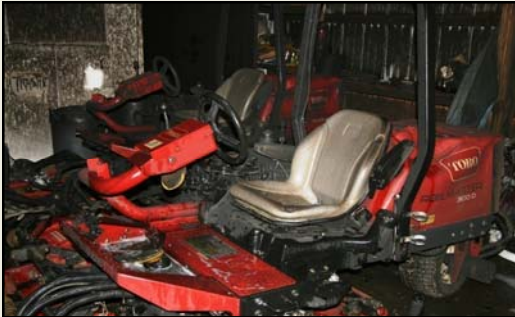
Mower Plastic Damage

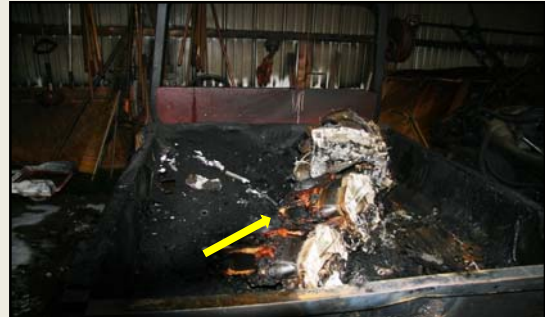
Four Stihl Blowers

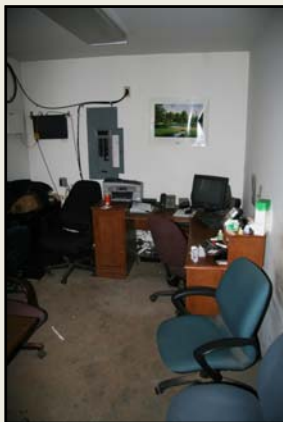
Office Area with Little Damage

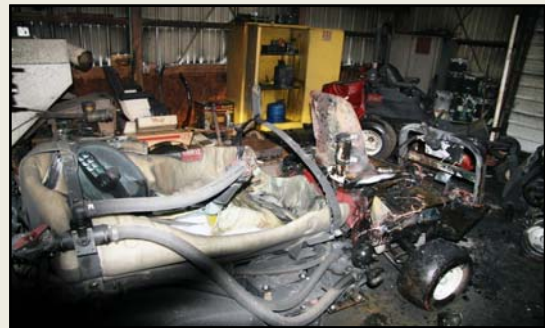
Sprayer Destroyed

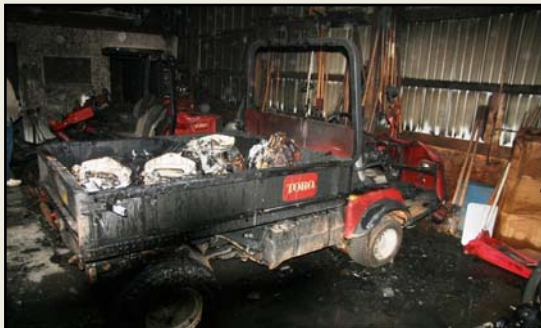
Workman Plastic Melted

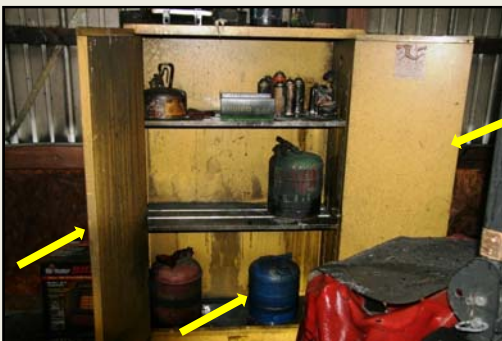
- Flammables Not in Flammable Cabinet
- Flammable Cabinet NOT Closed
- Contact Phone List Not Accurate
- Access Not Documented (Cameras)
- Keys in Ignition
- Fuel Can in Cart Seat
- Insurance Payment Delay

Flammable Cabinet

- Flammable Storage
- Fire Alarms
- Cameras
- Motion Detectors
- Fire Protection System (Sprinklers)
- Key Box
- Access Control
